## Incident ID

4b42d3ac-41a5-41a3-b492-17f2ea7c4217

Vehicle brand Toyota

Vehicle model Camry 8 XV70

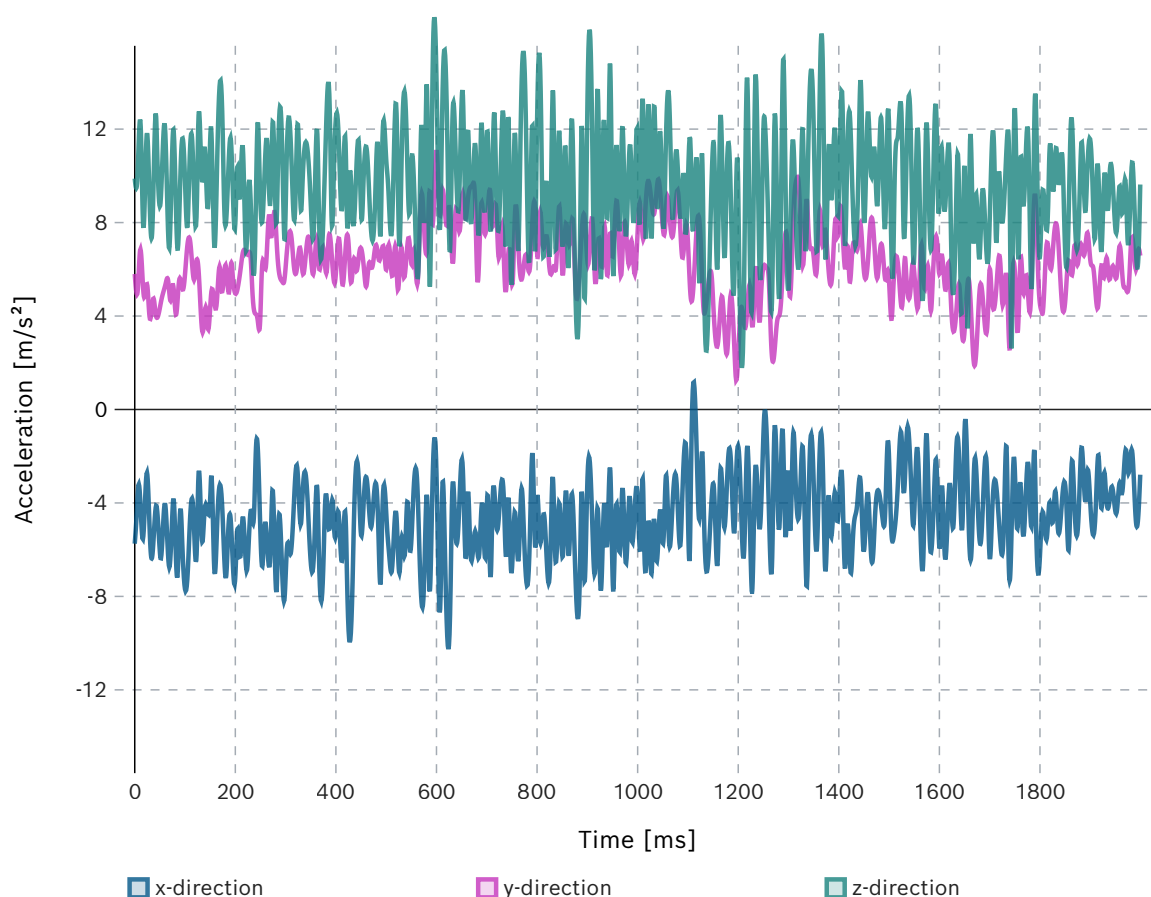
Severity

Severe

Impact area

Rear

Front right

68 mi/h

Data point at 0 ms was acquired at: 11/21/2025, 05:40:23.021 AM GMT -6
