## Incident ID

4b42d3ac-41a5-41a3-b492-17f2ea7c4217

Vehicle brand Toyota

Vehicle model Camry 8 XV70

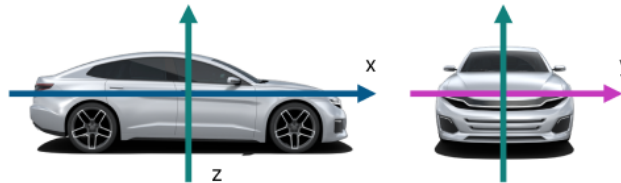
The damage detection on the exterior of the vehicle is based on the sensor measurements of the vehicle dynamics using the accelerometer & gyro data signals. Those signals are visualized as graphs for each of the three vehicle axis.
